Comparative performance of Fibre Reinforced Polymer and Fibre Reinforced Cementitious Mortar Strengthening Systems in Elevated Temperature Service Environments

Structural Faults and Repair 2010

COMPARATIVE PERFORMANCE OF FIBRE REINFORCED POLYMER AND FIBRE REINFORCED CEMENTITIOUS MORTAR STRENGTHENING SYSTEMS IN ELEVATED TEMPERATURE SERVICE ENVIRONMENTS

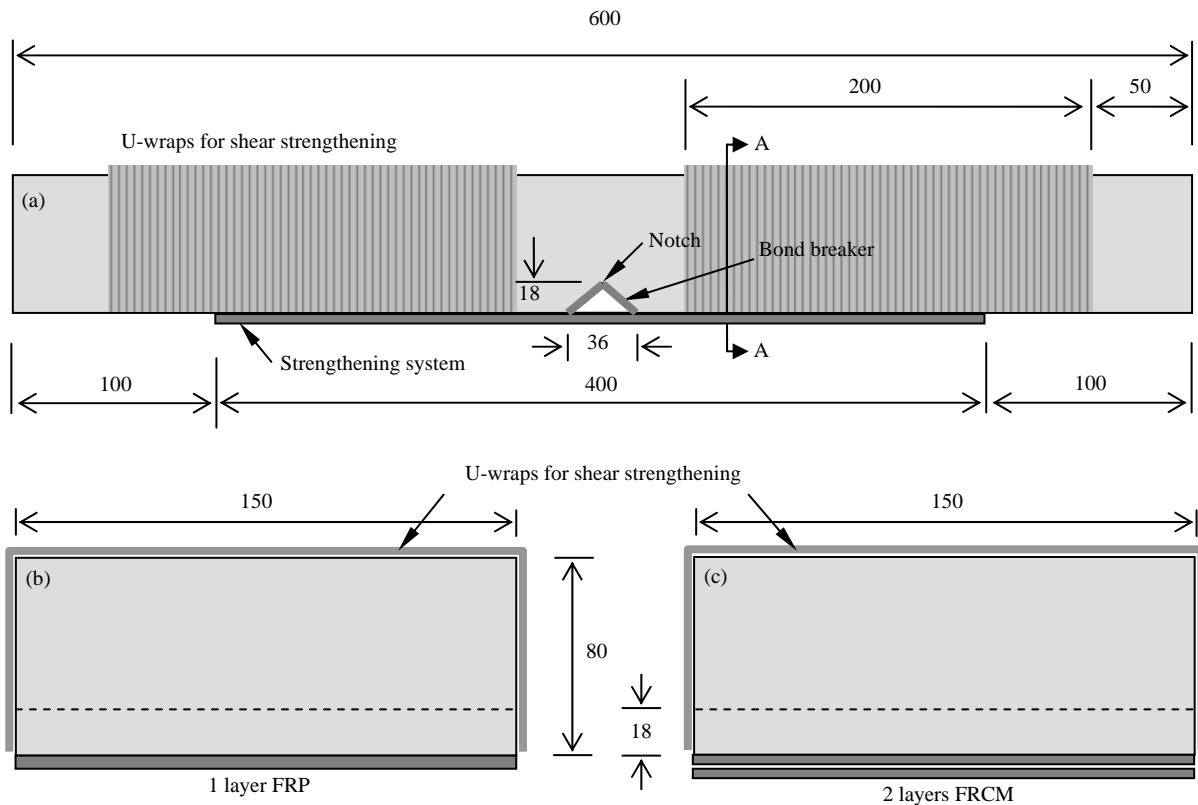
Fig. 1 Schematics showing (a) side elevation view of details of flexural test specimens and Section A-A views for (b) FRP strengthened and (c) FRCM strengthened specimens (all dimensions are in mm).

The dimensions and details of the concrete beam specimens are provided in Fig. 1. The beams were designed, such that the results could be compared against previous in-house testing performed by the industrial partner. The compressive strength of the concrete at the time of testing was 41.0 MPa with a standard deviation of ± 5.1 MPa at 20°C, as determined from three uniaxial compression tests on standard 100 mm diameter by 200 mm tall concrete cylinders. There was no internal steel reinforcement

whatsoever in the beams. All beams had a small, triangular (36 mm wide \times 18 mm deep) notch at midspan to act as a crack initiator within the constant moment region during testing (see Figs 1 and 4).

As shown in Table 1 and Fig. 1, eighteen beams were strengthened with a single layer of one of two different externally bonded carbon/epoxy FRP strengthening systems using an epoxy primer and epoxy saturant/adhesive. The full width of the beams' soffits were plated with FRP. Both systems were applied using a wet lay-up procedure at ambient conditions (i.e. no post cure) in the laboratory. The primer was allowed to cure for 24 hours before the carbon FRP fabric (Ruredil X Wrap 310) was saturated and applied using a hand lay-up procedure. The beams were cured for four months in the laboratory (at room temperature and ambient relative humidity) prior to testing.

As shown in Table 1 and Fig. 1, nine beams were strengthened with the Ruredil X Mesh Gold FRCM strengthening system. The amount of FRCM fabric used to strengthen the beams (a full width of 150 mm with two layers on each beam as shown in Fig. 1) was chosen to provide a similar axial stiffness as the two CFRP strengthening systems, so as to achieve similar flexural stiffness as the FRP strengthened beams. The FRCM was installed using the following general procedure (refer to Fig. 2):

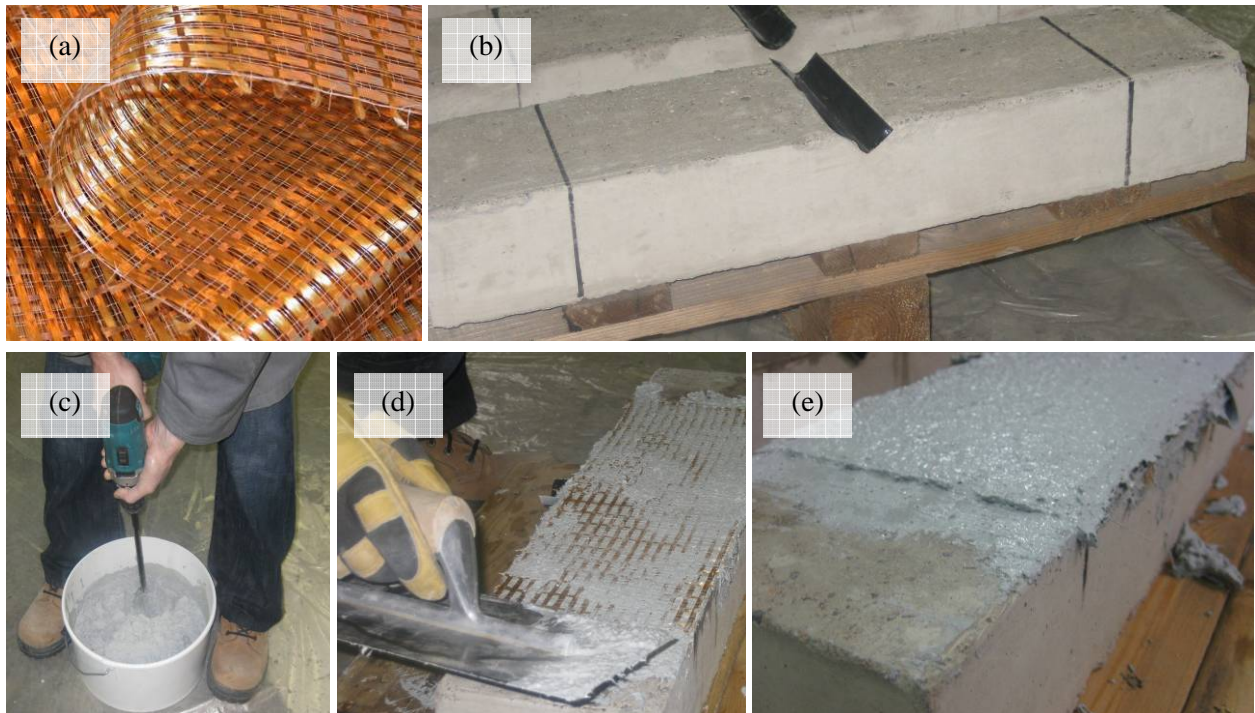
Fig. 2 (a) Open-weave PBO fibre fabric and (b, c, d, e) steps in the installation of the FRCM system.

2. A bond breaker, consisting of polymer adhesive tape, was applied within the notch so as to prevent bond between the mortar and the concrete within the notch (and thus to allow the notch to function as a crack initiator) (refer to Fig. 2b).

3. The Ruredil X Mesh M750 mortar/adhesive was mixed using a hand drill with a mixing paddle (Fig. 2c) and a thin layer of mortar, approximately 4 mm thick, was applied to the beam's soffit (note that the beams were strengthened upside-down for ease of application).

4. One layer of open-weave Ruredil X Mesh PBO fabric (shown in Fig. 2a) was placed on the beam's soffit and gently pressed into the inorganic mortar using a finishing trowel (Fig. 2d).

5. A second 4 mm layer of mortar was applied to the surface of the beam.
6. A second layer of PBO mesh was gently pressed into the mortar.
7. A final topcoat of mortar, again approximately 4 mm thick, was applied (Fig. 2e).

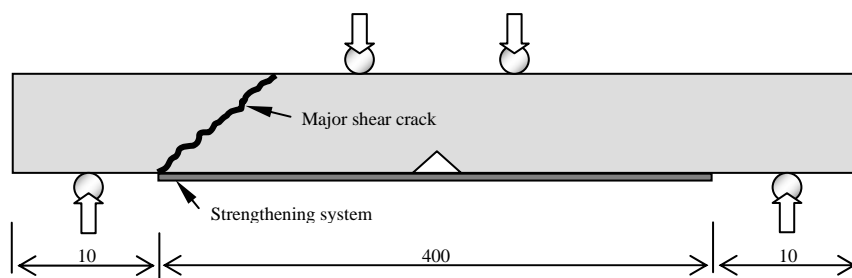
Fig. 3 Shear failure mode experienced in initial tests which led to the shear strengthening scheme used on the remaining specimens.

Initial pilot tests performed on two FRP strengthened beams showed that at room temperature the strengthened beams experienced a shear failure mode which initiated at the end of the FRP strengthening system; this is shown schematically in Fig. 3, below.

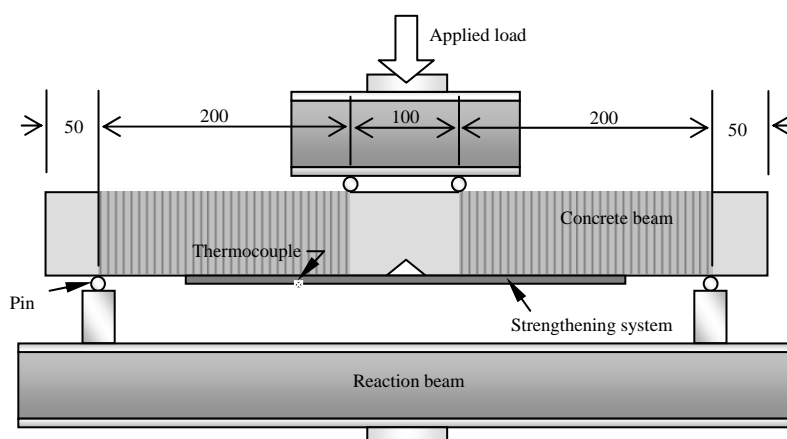
Fig. 4 Test setup and instrumentation (all dimensions are in mm).

All 36 beams were tested in four-point bending as shown in Fig. 4. Conventional instrumentation was used to collect load (load cell), vertical displacement (crosshead stroke displacement), and temperature (thermocouples) data during testing (refer to Fig. 4). A total of 12 beams were tested at ambient temperature (3 of each type) to determine the level of strengthening achieved and the failure mode(s). All beams were tested monotonically under crosshead displacement control to failure, at a rate of 0.5 mm/min. The remaining 24 specimens tested monotonically under crosshead displacement control to failure at a rate of 0.5 mm/min, after being heated for six hours (without any applied load) in an electrical drying oven at either 50°C or 80°C. These temperatures, as well as the total heating time of six hours, were essentially arbitrary but were chosen so as to ensure a uniform member temperature prior to testing.

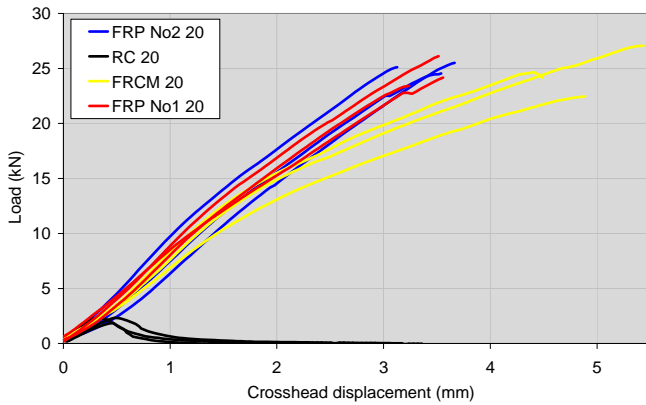
Fig. 5 Load versus vertical deflection at midspan for specimens tested at ambient temperature.

Fig. 5 shows the total applied load versus midspan vertical deflection (based on crosshead stroke data) behaviour of all 12 beams tested at ambient temperature. The unstrengthened control beams (PC 20) displayed typical unreinforced flexural behaviour for concrete, with very low ultimate load due to failure as soon as the cracking moment was exceeded. These beams displayed a post-peak softening load-deflection response due to friction at the external supports (which allowed rotation but prevented lateral displacements), leading to mild arching action during the softening phase.

The FRCM beams were slightly less stiff than the FRP strengthened beams, and displayed correspondingly larger midspan displacements prior to failure (refer to Fig. 5). The FRP strengthened

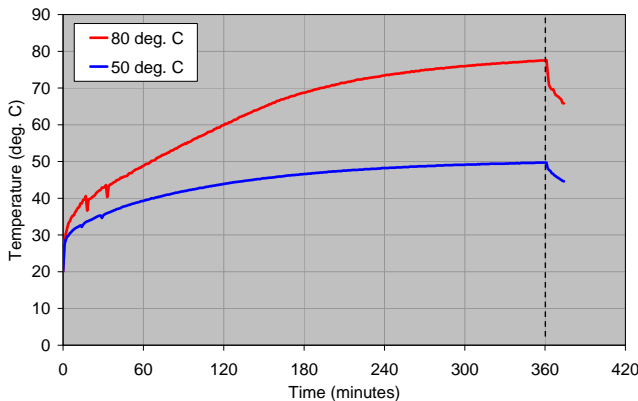
Fig. 6 Average surface temperature versus time of heating for specimens tested at target temperatures of 50°C and 80°C.

Fig. 6 shows traces of temperatures recorded on the surface of the strengthening system for typical beam heated for 6 hours to 50°C or for six hours to 80°C. The figure shows that the desired specimen temperature of 50°C was achieved after six hours, but that the specimens intended to reach 80°C actually reached peak temperatures of 78°C. The recorded temperatures were very similar in all cases and were not sensitive to the type of strengthening system applied to the beams. Fig. 6 also shows that the surface temperature of the applied strengthening system dropped by up to 10°C (for the 80°C tests) during testing (since the beams had to be removed from the oven and quickly placed in the testing frame and tested). However, it is unlikely that the bond line temperature dropped by more than one or two degrees during testing.

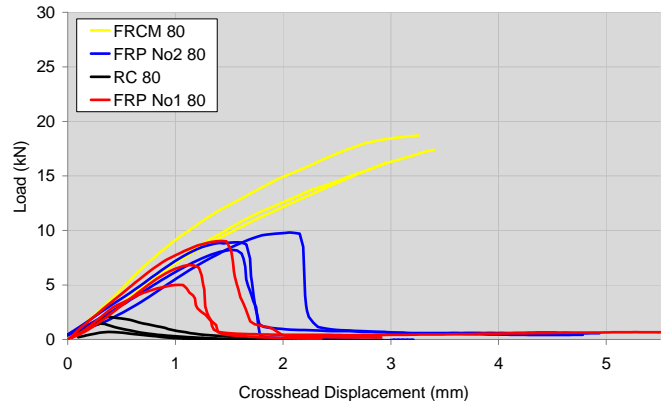
Fig. 8 Load versus vertical deflection at midspan for specimens tested at 80°C.

Fig. 8 shows the total applied load versus midspan vertical deflection behaviour of all 12 beams tested at 80°C. The unstrengthened control beams (PC 80) displayed similar behaviour as the unstrengthened beams tested at room temperature, although again with slightly lower strength on average. The strengthened beams again exhibited large strength increases compared with the unstrengthened control beams, although the strength increases were drastically reduced for both of the FRP strengthening systems, and slightly reduced for the FRCM strengthened beams.

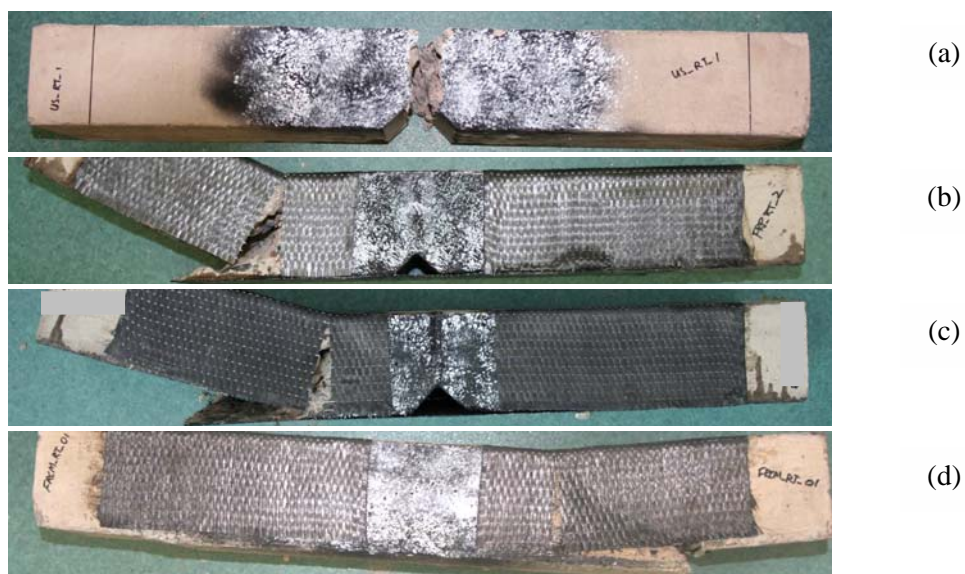
Fig. 9 Typical failure modes: (a) unstrengthened, (b) FRP N°1, (c) FRP N°2 & (d) FRCM at ambient.

beams showed a considerably stiffer post-cracking responses; this despite the fact that the FRCM strengthening system was designed on the basis of equivalent axial stiffness and had a slightly larger flexural lever arm (because of its additional installed thickness as compared to the FRP system). While the reasons for the less stiff response of the FRCM strengthened beams are not known with certainty, it seems likely that micro-cracking of the FRCM's cementitious mortar resulted in partial redistribution of tensile strains in the FRCM as the load increased, with a subsequent reduction in the system's effective flexural stiffness. Additional testing on beams of various depths/sizes with different levels of FRCM strengthening is required to verify this hypothesis. The two different FRP adhesive systems showed similar responses to each other. Typical shear failure modes for each type of beam at room temperature are shown in Fig. 9.

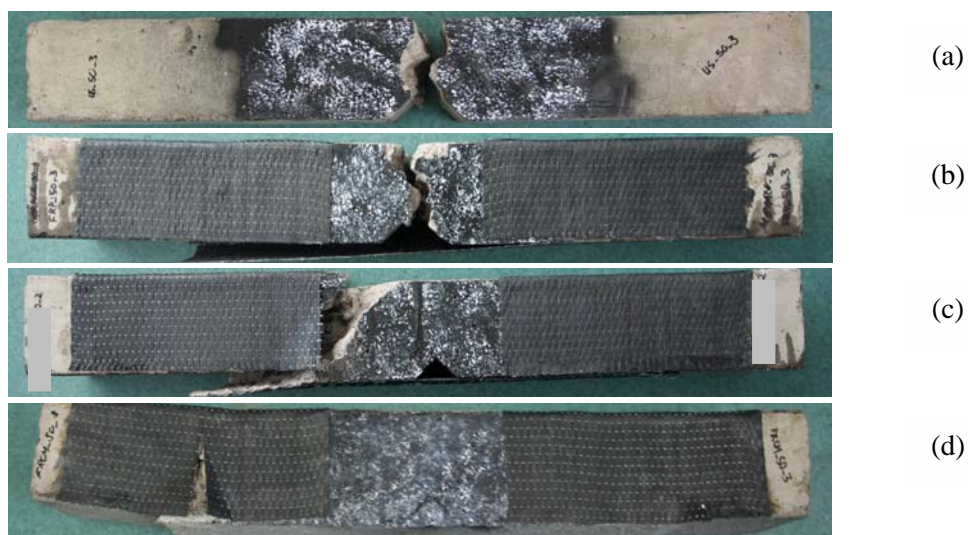
Fig. 10 Typical failure modes: (a) unstrengthened, (b) FRP N°1, (c) FRP N°2 & (d) FRCM at 50°C.

At 50°C the FRCM beams were as (or more) strong and stiff as either of the FRP strengthened sets. The FRCM and FRP N°2 strengthened beams again failed by sudden shear failure of the concrete beams, again initiating at the termination of the strengthening system (Fig. 3), with the strengthening systems remaining essentially intact. The FRCM beams were no longer less stiff than the FRP strengthened beams (refer to Fig. 7). The beams strengthened with FRP N°1 experienced considerable reductions in strength and stiffness, and also displayed a debonding failure mode rather than shear failure of the concrete; this is clear evidence of softening of the adhesive and reductions in the FRP N°1-concrete bond strength and stiffness at 50°C. Typical failure modes for each type of beam at 50°C are shown in Fig. 10.

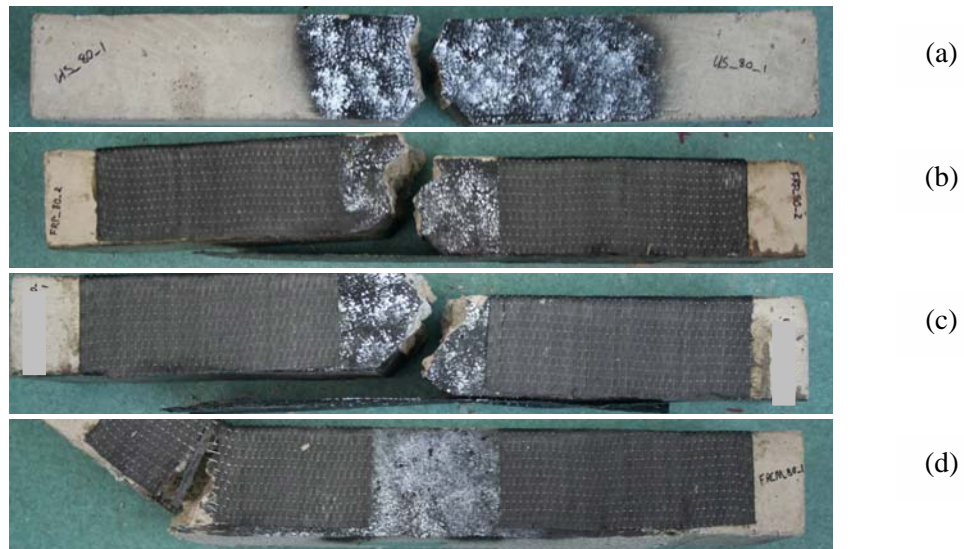
Fig. 11 Typical failure modes: (a) unstrengthened, (b) FRP N°1, (c) FRP N°2 & (d) FRCM at 80°C.

At 80°C the FRCM strengthened beams were clearly the strongest and stiffest set. The FRCM strengthened beams continued to fail by sudden shear failure of the concrete beams, initiating at the termination of the strengthening system (Fig. 3), with the strengthening system apparently remaining intact. The beams strengthened with FRP N°1 or FRP N°2 experienced considerable reductions in strength and stiffness, and also displayed debonding failure modes rather than shear failure of the concrete; again, clear evidence of softening of the adhesive and major reductions in the FRP-concrete bond strength and stiffness at 80°C for both FRP systems. Failure modes for each type at 80°C are shown in Fig. 11.

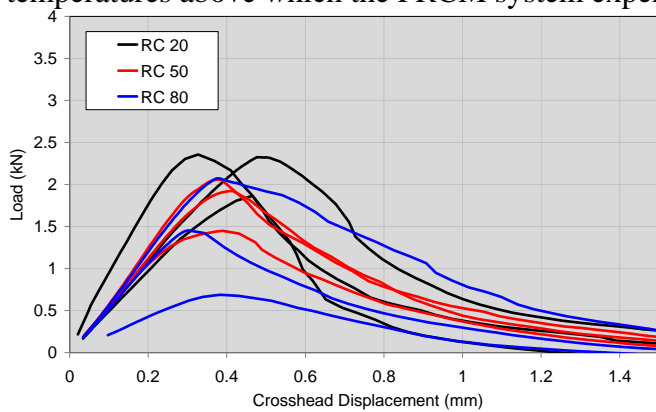
Fig. 12 Load versus vertical deflection at midspan for all unstrengthened specimens.

The effect of increasing temperature exposure on the respective strengthening systems is shown visually in Figs 12 (PC beams), 13a (FRP N°1 strengthened beams), 13b (FRP N°2 strengthened beams), and 13c (FRCM strengthened beams). These figures clearly demonstrate the superior performance of the FRCM strengthening system as compared with the FRP systems at both 50°C and 80°C. Fig. 14 compares the strengths of all beams tested in the current study, and also provides trend lines which represent the average strength for each type of beam at each exposure temperature. Again, the superior performance of the FRCM strengthened beams is clear. Fig. 15 shows the same data as are given in Fig. 14, although the data have been normalized against the average room temperature strength of the FRCM strengthened beams so as to give a relative comparison of the performance of the FRCM strengthened beams against

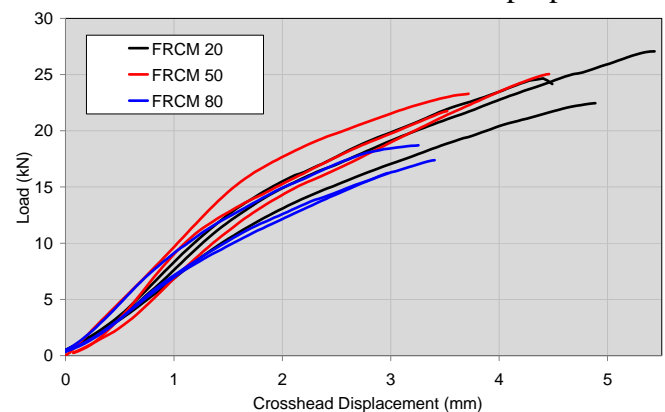
Fig. 13 Load versus vertical deflection at midspan for (a) all FRP N°1 strengthened specimens, (b) all FRP N°2 specimens, and (c) all FRCM specimens.

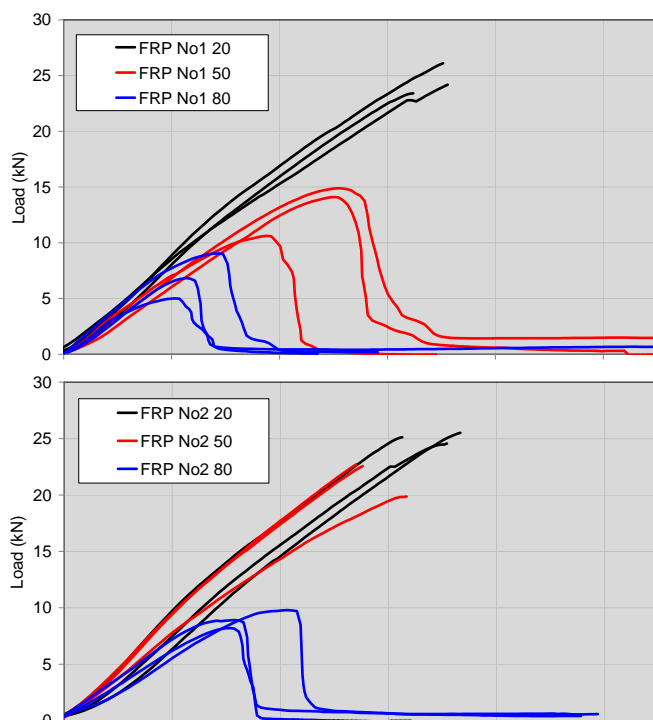
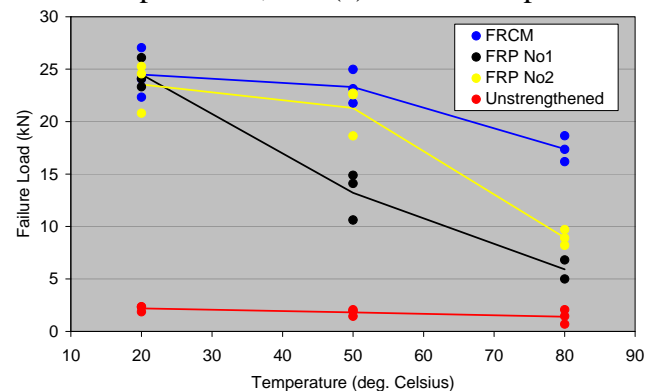
Fig. 14 Reductions in load capacity with increasing exposure temperature for all strengthened specimens (lines show averages).

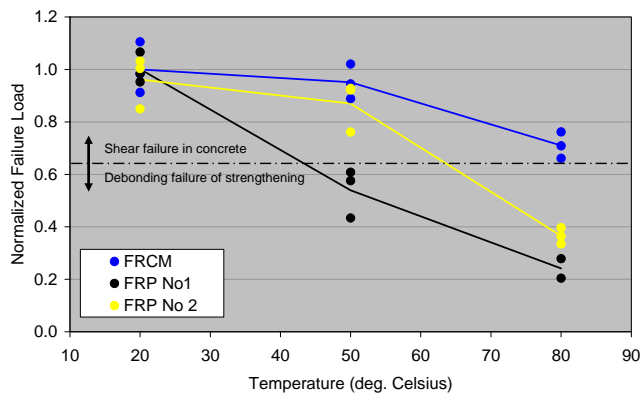
Fig. 15 Reductions in load capacity with increasing exposure temperature for all strengthened specimens (normalized to the average room temperature strength of the FRCM strengthened beams, lines show averages).

the beams strengthened with FRP. Also shown in Fig. 15 is a horizontal line giving the approximate load level at which the beam failures transitioned from shear failure in the concrete outside the strengthened length to debonding failure of the strengthening system. This load level was about 65% of the room temperature average strength of the FRCM strengthened beams. Thus, any beam failing above the 65% line may not have experienced any reduction in strength of the strengthening system, since the failure was in the concrete.

Fig. 15 appears to indicate a reduction in strength of the FRCM system with increasing exposure temperatures. However, Fig. 16 shows the reduction in strength observed for the unstrengthened concrete beams, wherein a reduction in strength of about 15% was observed at 50°C and about 35% at 80°C. This suggests that the tensile strength of the plain concrete beams themselves was significantly reduced at these exposure temperatures. Since the FRCM strengthened beams continued to fail in shear at both 50°C and 80°C (with similar load capacity reduction magnitudes as those observed for the unstrengthened beams), it appears that the reduction in strength for the FRCM strengthened beams may represent a reduction in the tensile/shear strength of the concrete, rather than in the mechanical or bond properties of the FRCM system. Additional testing, at higher temperatures, would be required to clearly define the temperatures above which the FRCM system experiences reductions in mechanical and bond properties.

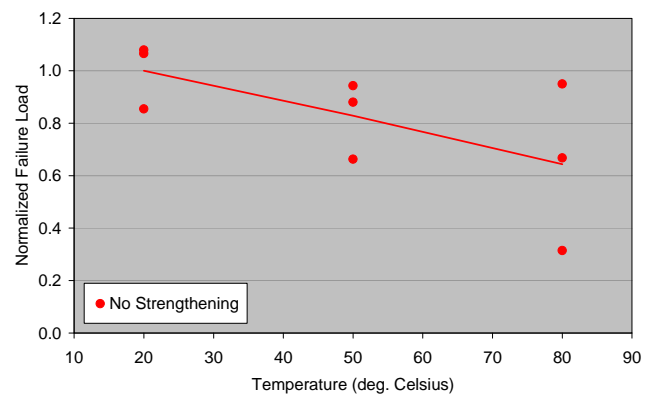
Fig. 16 Reductions in load capacity with increasing exposure temperature for unstrengthened specimens (normalized to ave. room temp. strength of unstrengthened beams, line shows average).
